**Issued: March 29, 2019**

Chazen Engineering, Land Surveying, and Landscape Architecture Co., D.P.C.  
21 Fox Street  
Poughkeepsie, NY 12601  
Office: 845-454-3980

## **1.0 PROJECT DESCRIPTION**

The Applicant, Lincoln Park DG LLC, seeks site plan approval pursuant to the Town of Ulster Zoning Law to construct a battery array to provide capacity and ancillary services to the regional electric grid by absorbing (charging) and generating (discharging) electricity as directed by the grid operator (Lincoln Park Grid Support Center (LPGSC)) on part of a ten-acre parcel identified as part of Tax Parcel 48.12-1-20 (Project Site) in the Town of Ulster (see Figures 1 and 2). A 20 MW battery-only energy storage facility requires approximately 25,000 battery modules with a collective capacity of approximately 80 megawatt hours (MWh), eight (8) inverters within an approximately 30,022 square foot (SF), one-story building. The battery array will be enclosed in racks with each rack containing multiple modules and each module containing individual battery cells that include on board monitoring in real time, including fire safety monitoring. The battery modules will be divided into several ban

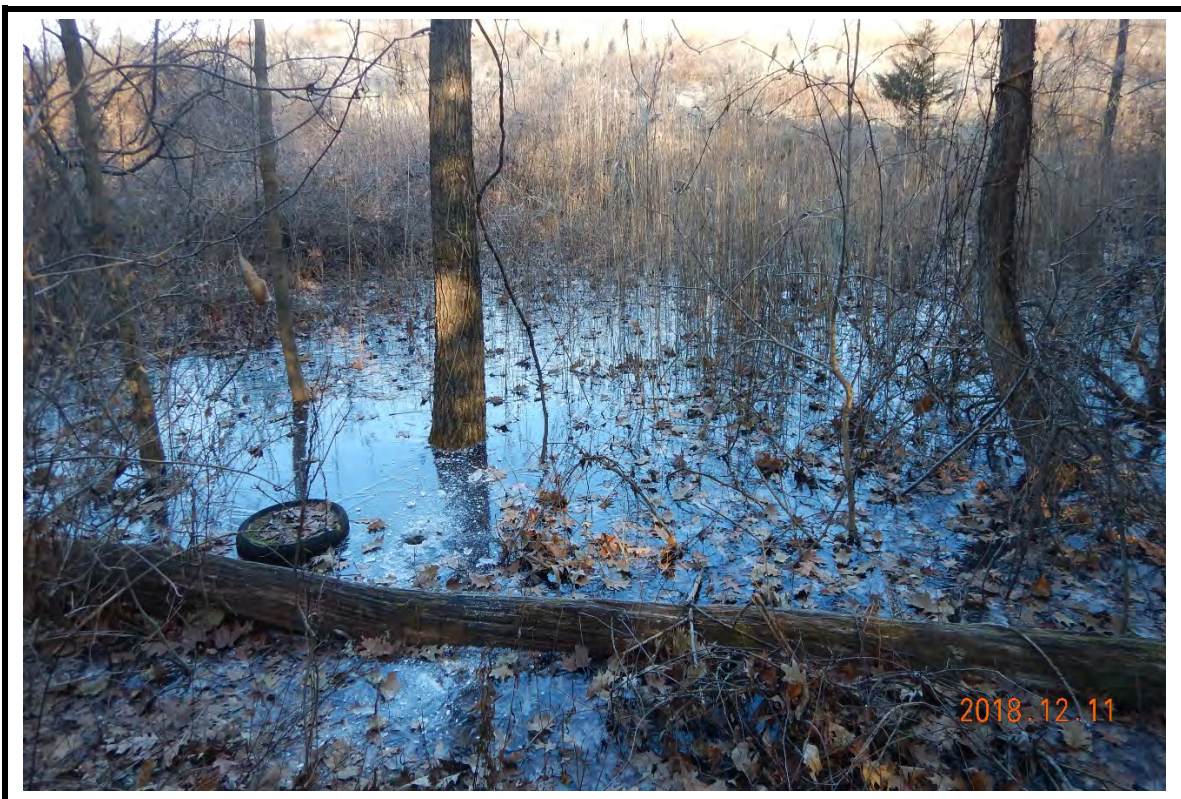
Photo #1

Description: View north of Wetland A. This wetland contains forested and ponded habitat.

- Red Maple-hardwood swamp: Several of the wetland systems found on-site can be categorized as red maple hardwood swamps, including Wetland A, B, C, and D. These wetlands lie within depressions and one (Wetland C) is associated with an off-site stream. The wetlands are dominated by red maple, American hornbeam, and sensitive fern. highbush blueberry, and spicebush were the main shrubs identified in these wetlands. See Attachment E, Photos 1, 2, 5, 6, 9, and 13.

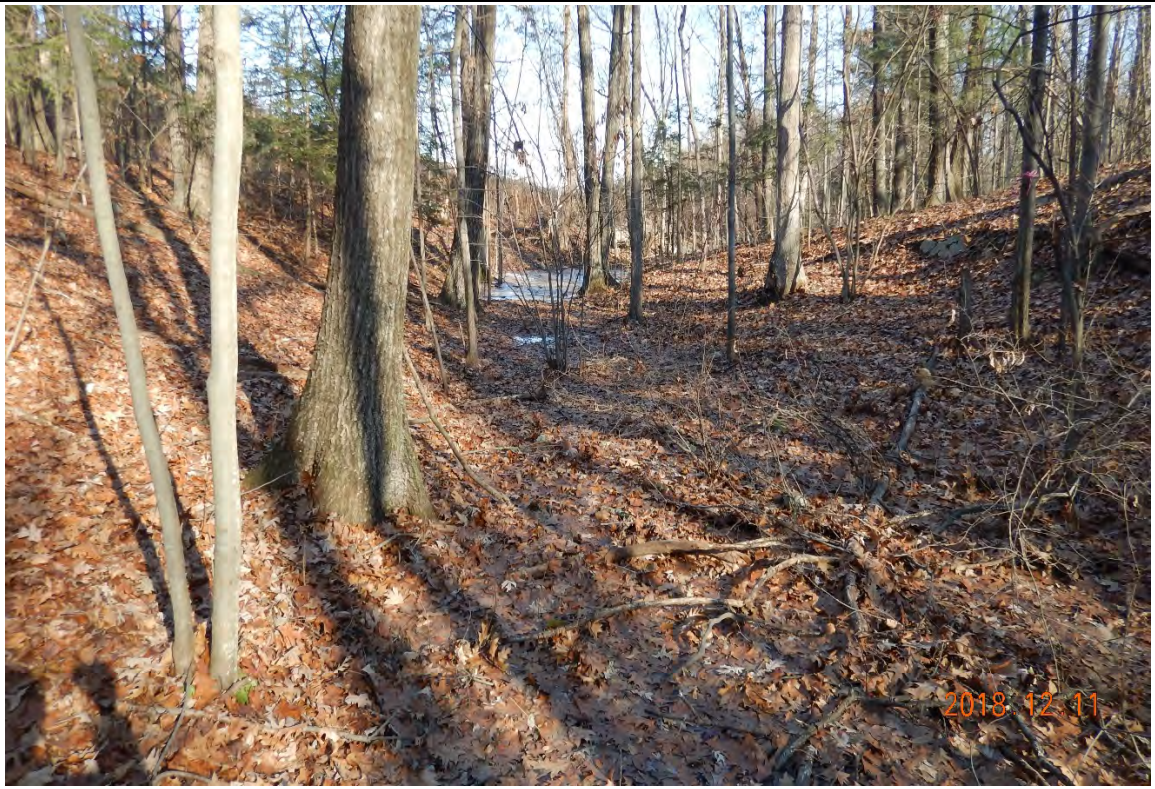
Photo #5

Description: View north of Wetland B a forested wetland.

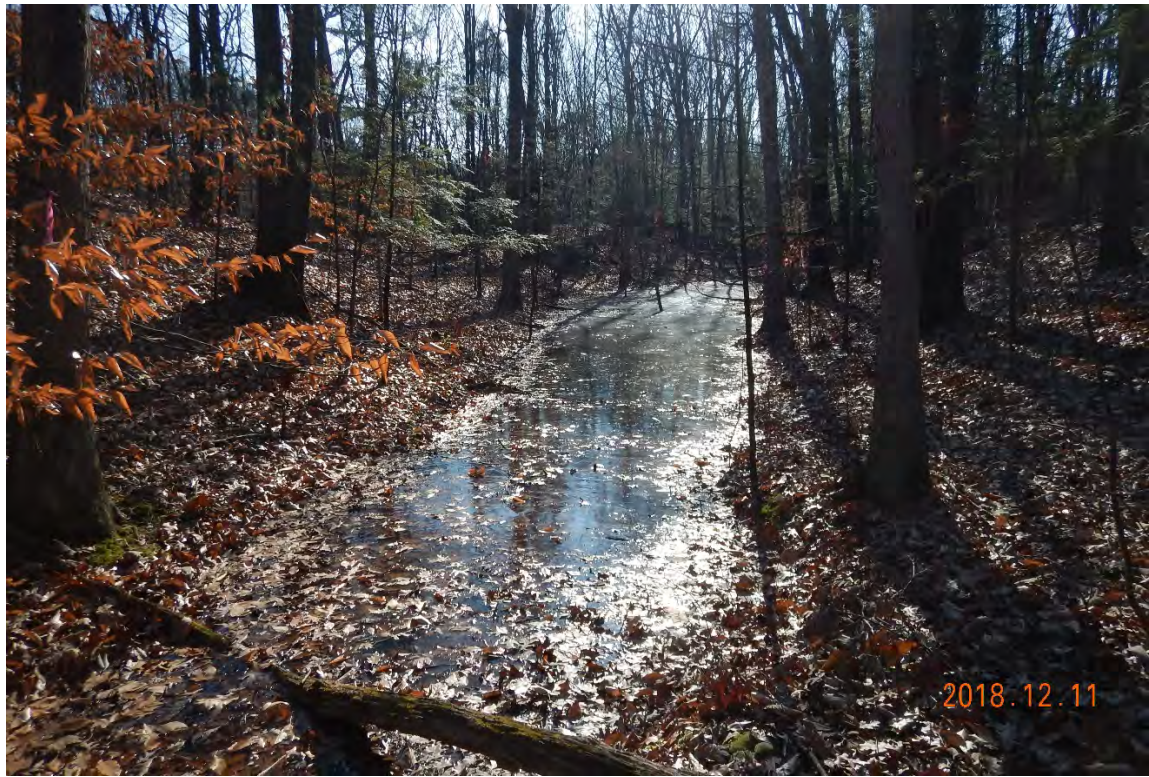
Photo #9

Description: View south of a portion of Wetland C.

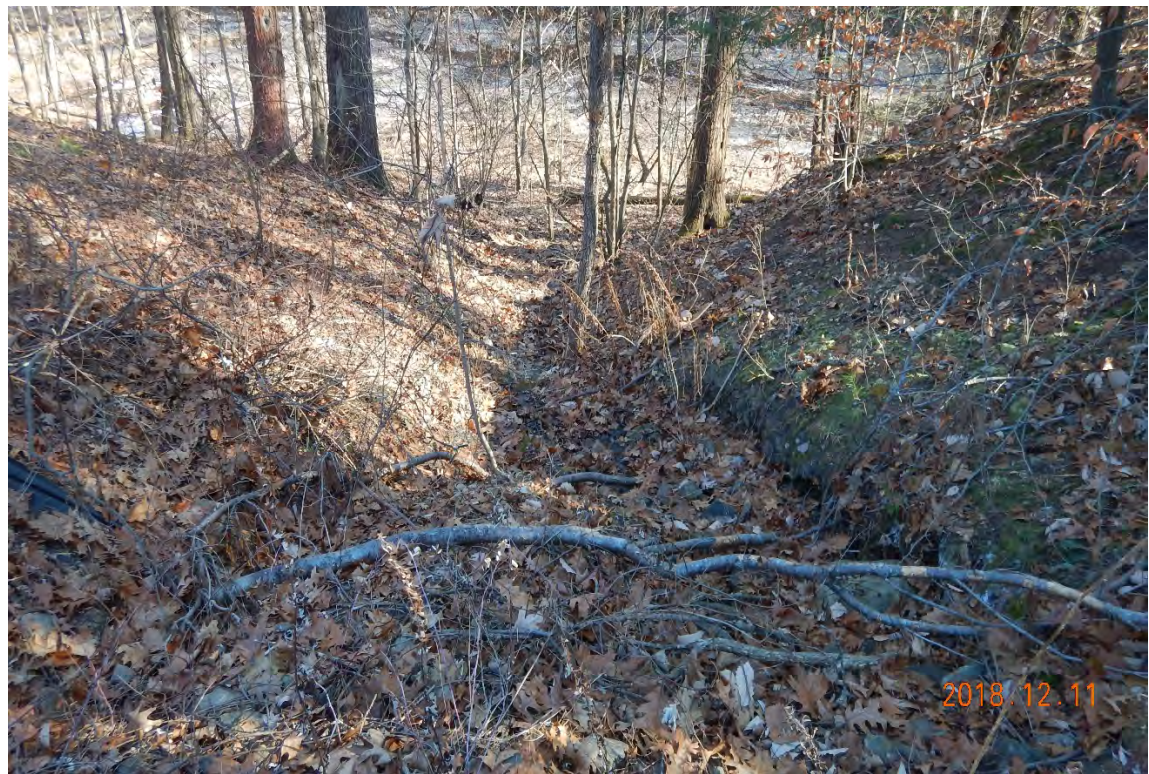
Photo #10

Description: View east of the off-site stream that is partially fed by Wetland C.

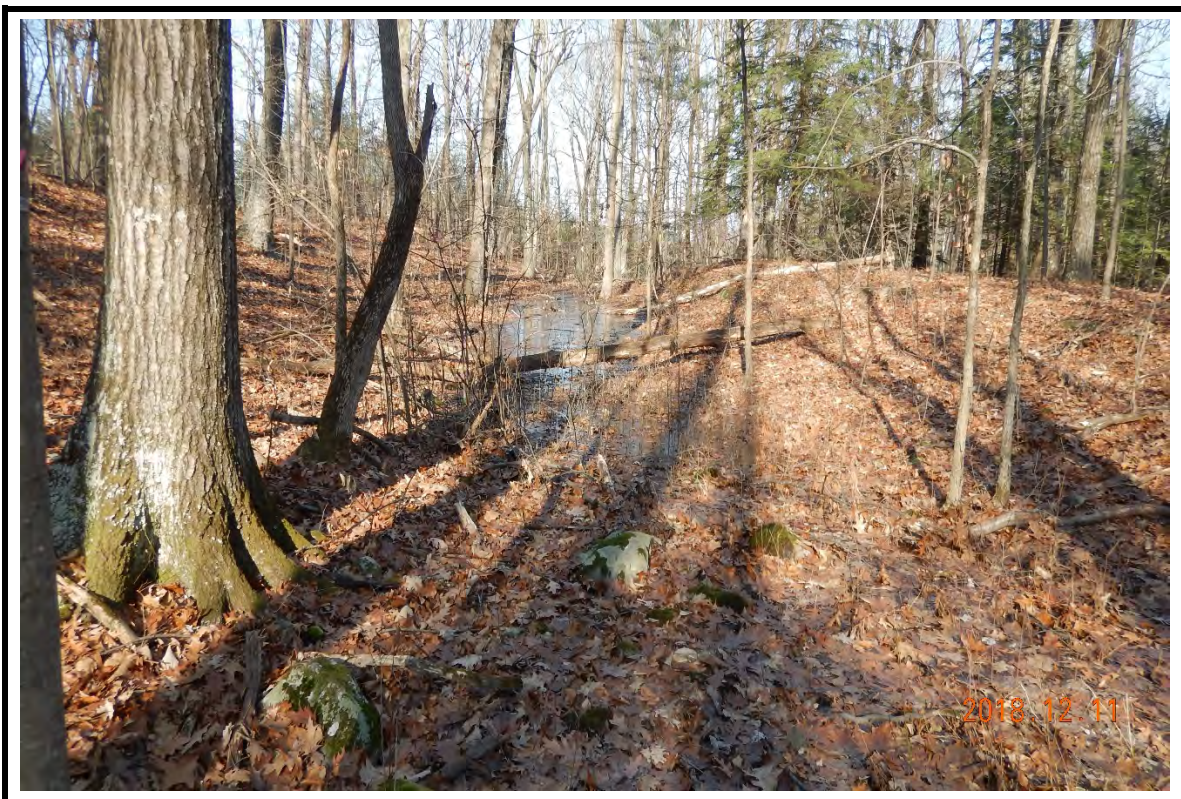
Photo #13

Description: View north of Wetland D a forested wetland between rock outcrops.

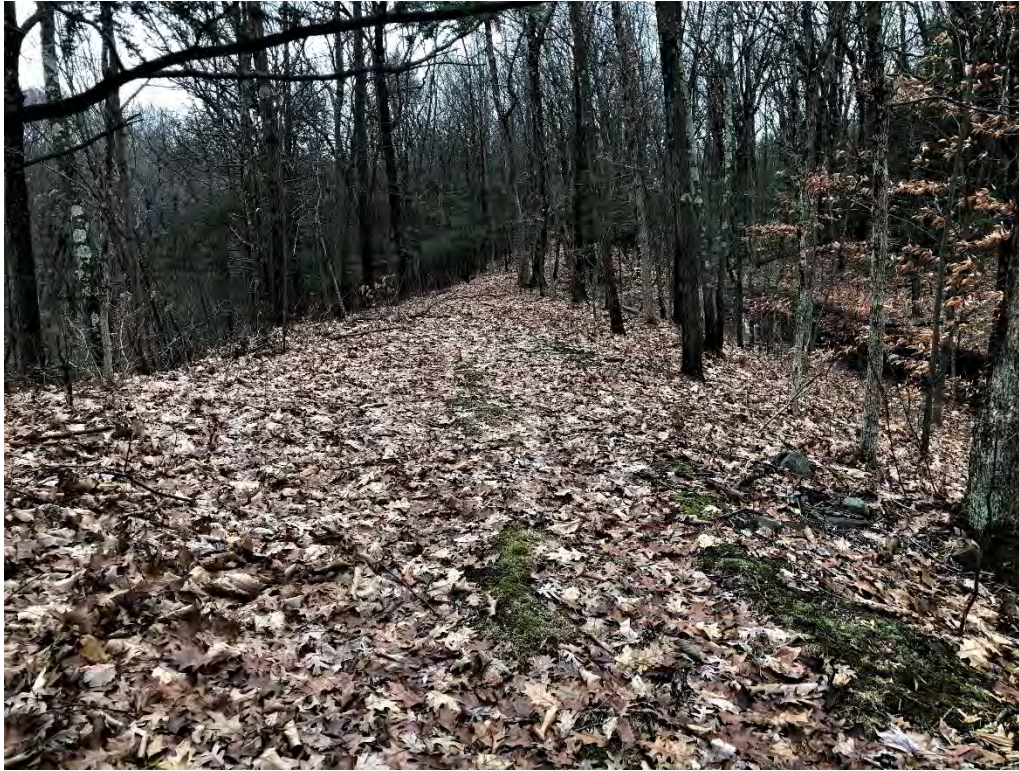
Photo 7. View facing southeast of the ridge along deep ravine running the length of the east side of the Project Area where the majority of positive tests were located.

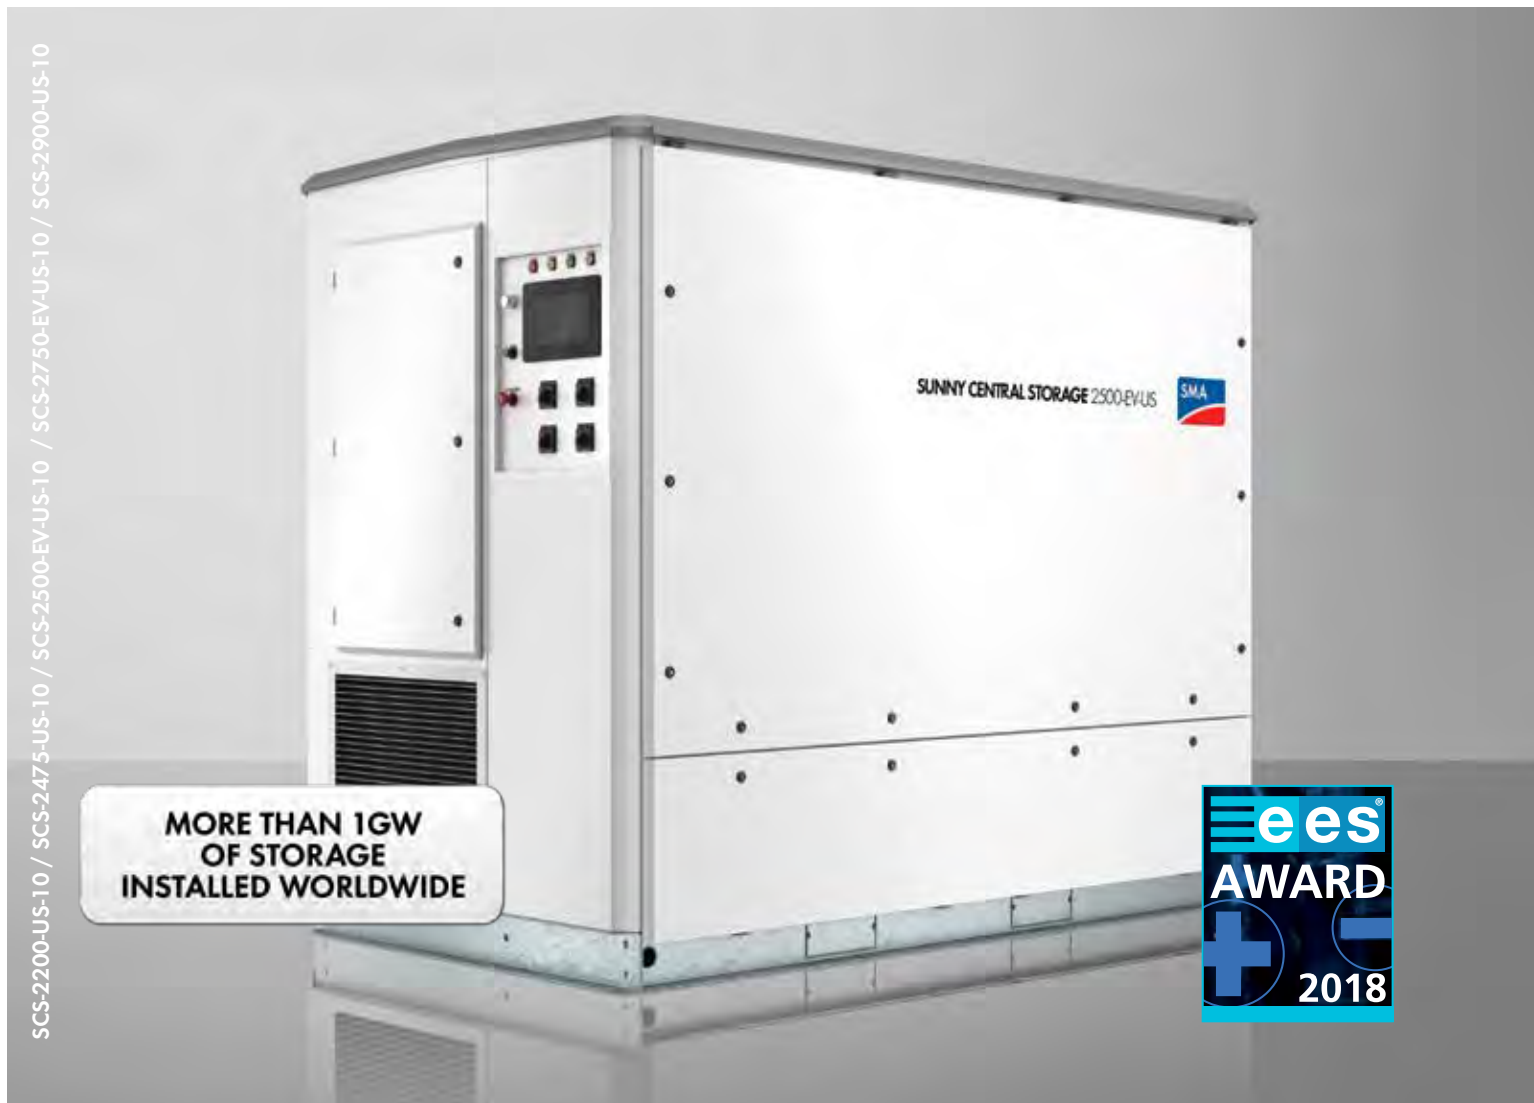
# SUNNY CENTRAL STORAGE

- High power density
- Max. efficiency is 98.7%
- Lower transportation costs (up to 4 inverters in a standard shipping container)
